Dismantling a Meade ETX

By **Keith Ehren**

These notes concern my Meade ETX105. Meade have since replaced this model with the ETX-PE (Premier Edition) but there are still plenty of people using these and there are lots for second hand sale.

My ETX105 conked out during a slew. Declination motor was still working so my attention was drawn to the RA.

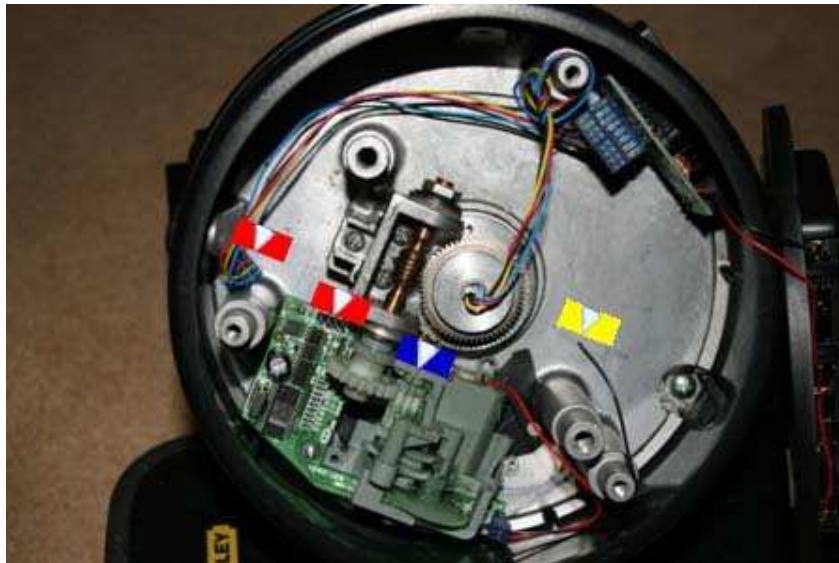
Now you can see the motor, gear train assembly and the worm and wheel assembly for the RA drive. Three things of note here:-

- I have disconnected a multi-plug from the circuit board (red arrows);
- One wire to the motor (black) is broken - arrowed in yellow;
- There was a great big crack in the plastic gear train housing – arrowed in blue;

Clearly the crack and/or wire break were the causes of the RA drive failure. I was quite disappointed by the amount of plastic being used here.

Fig. 12 – Interesting use of materials; a plastic gear assembly!

With liberal and very careful use of super glue I am now back up and running.

Top Tip: I now always slew at slow speeds to limit the torque peaks and therefore stress being placed on the gear train (something I also do on my LX200). So far it's holding out!

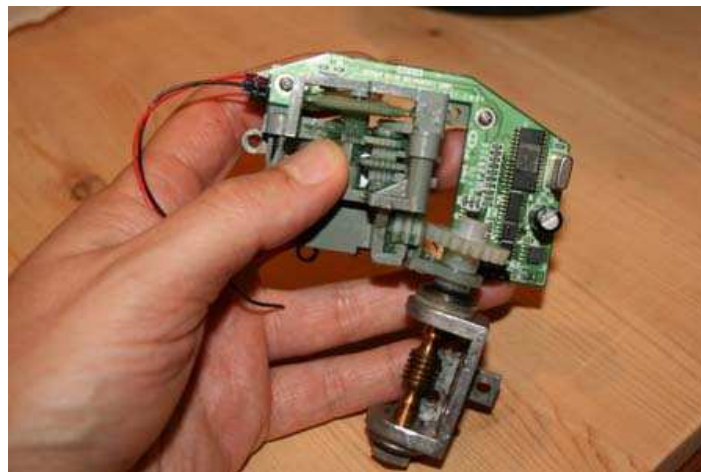
You can now lift free the assembly, which in my case promptly fell into two parts showing that the crack was in fact a complete sheer and failure. Clearly the plastic had suffered a stress fracture.

Fig. 15 – Broken gear assembly about to fall into two parts

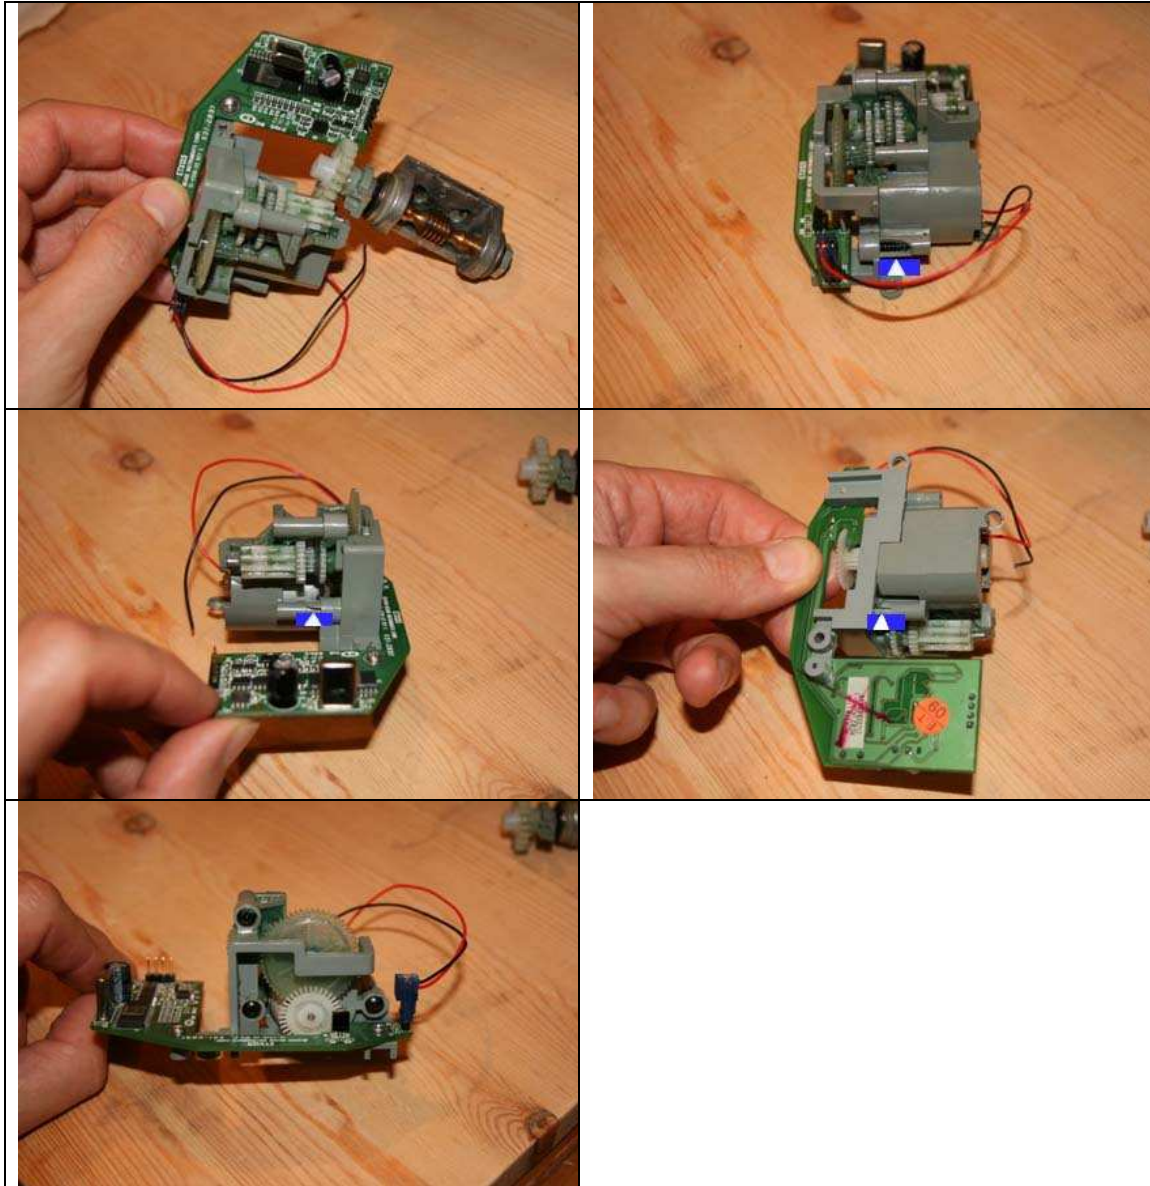
At this point my feeling of a rather disappointing piece of manufacturing and assembly was heightened upon inspection of the assembly. No fewer than five stress fractures were present; most of which were possibly due to the screws having been over-tightened during assembly breaking the plastic. They looked like failures just waiting happen.

Fig. 17 – Numerous stress fractures in the plastic assembly
