Dismantling a Meade ETX

By **Keith Ehren**

These notes concern my Meade ETX105. Meade have since replaced this model with the ETX-PE (Premier Edition) but there are still plenty of people using these and there are lots for second hand sale.

My ETX105 conked out during a slew. Declination motor was still working so my attention was drawn to the RA.

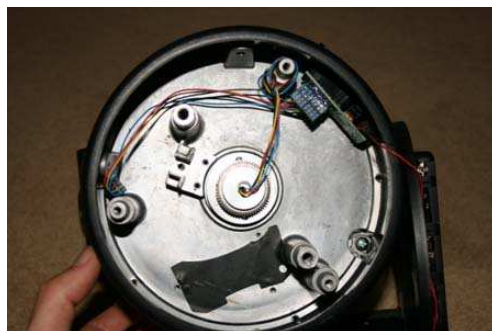
You can now lift free the assembly, which in my case promptly fell into two parts showing that the crack was in fact a complete sheer and failure. Clearly the plastic had suffered a stress fracture.

Fig. 16 – Base is now empty.
